Shriver-Davis Farm
Emmitsburg vicinity
Private

Maryland Historical Trust HISTORIC PROPERTIES State Historic Sites Inventory Form

Survey No. F-6-76 Magi No. DOE __yes __no

F-6-76 Shriver-Davis Farm Emmitsburg Frederick County

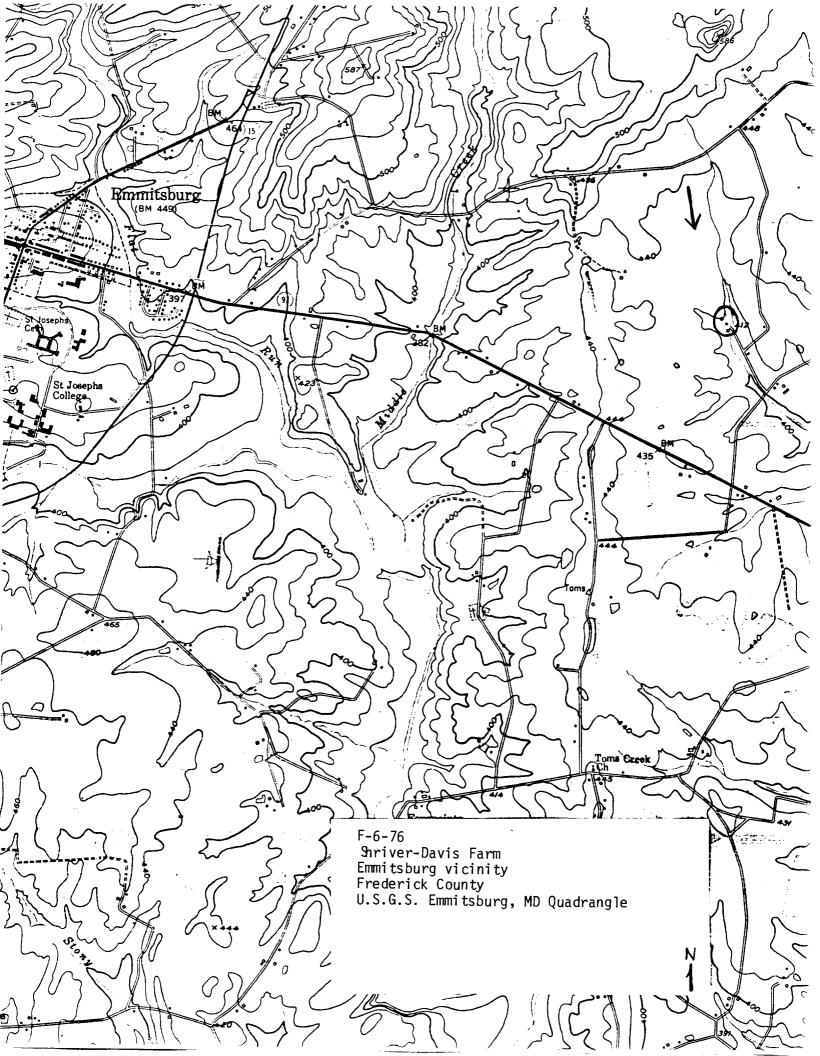
F-6-76 Shywry-Davis Farm Shriver Koad Emmitsburg vicinity Frederick Country Prote: Marry K SHIPE May 1991 Ny. loc: MHT vest elevation

Constructed circa 1840, the main house is of brick construction, 5:1 common bond, resting on a stone foundation. It is 2 stories with a 5 bay symmetrical facade. The gable roof is covered in slate shingles and has a boxed cornice with cornice returns. There are two interior end brick chimneys.

The main (west) facade has a center door with a transom and is flanked by 1/1 replacement windows. Windows on the second floor are 6/6. All openings have flat wooden lintels. A one story open porch runs the full facade with a dentilled cornice. There are 4 fluted columns with acanthus leaves and dentilled capitals. The east elevation is three bays wide. The first floor has an enclosed porch with a shed roof and turned columns. The second floor has three 6/6 windows.

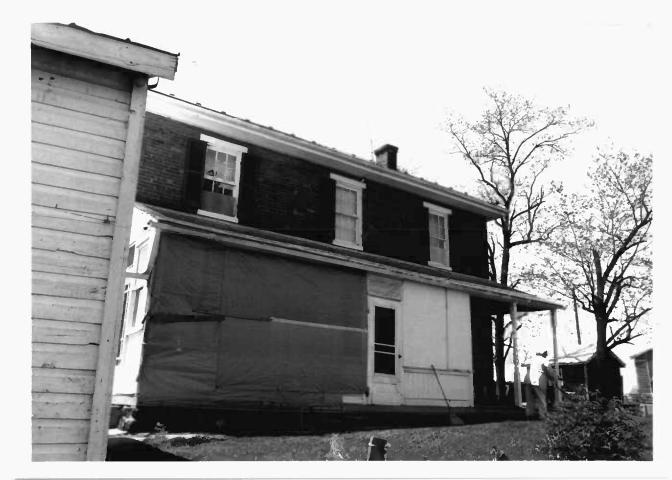
F-6-76 Shriver-Davis Farm Shriver Road Licinity Frederick Canty & SHIPE Photo: MARRY & SHIPE MAY 1991 Neg, Loc: Manyland Historical Inst East Elevation

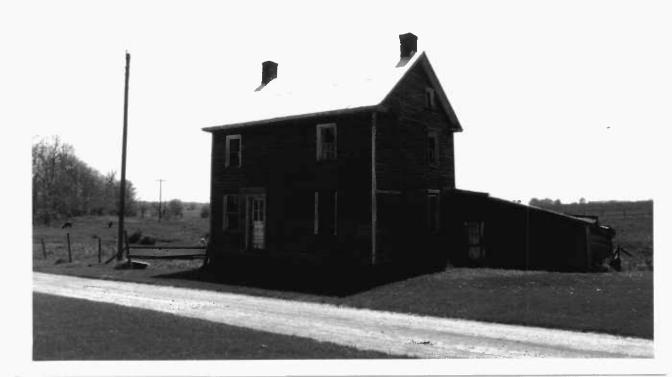
F-6-76 Shriver-Davis Farm Shriver Road Emmitsburg vicinity Frederick Centy PLAC: MARY K SHIPE May 1998 NY, LOC: MHT TENANT HOUSE - East Elevation

A two story frame tenant house on a stone foundation is located several yards to the west of the main house. It is sheathed in german siding and has a gable roof of standing seam tin. There are two interior end brick chimneys. Windows are 6/6 lights. The interior plan has three rooms. In the attic, there is a carved date and name: Frank -aldwell, March 18, 1887. A shed addition, german sided, extends from the west elevation of the building. The building is presently utilized for hay storage.

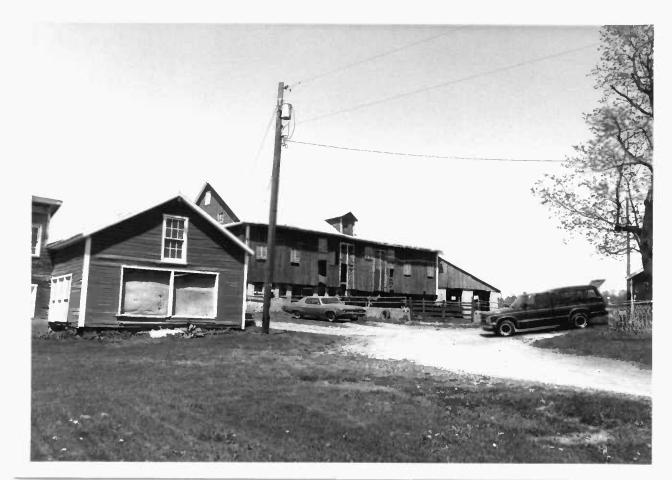
F-6-76 Shriver-Davis Farm Shrwer Road Emmissing vicinity Frederick County PLate: MARY K SHIPE May 1991 Neg. Loc: MHT Agri-bldgs looking north

Agricultural operations include a bank barn with a stone foundation and vertical siding. It is decorated with louvred vent windows and has a standing seam tin roof. Two shed roof additions are attached to the west and east elevations. A cinder block silo is located to the north of the barn. A large shed roofed chicken coop is sheathed in german siding. It has multiple windows on the east elevation. A garage with a gable roof of corrugated tin is also sheathed in german siding. It has 6/6 windows and a panelled door. A vertical sided shed with a corrugated tin gable roof serves as a goose house.
